Blackburn Bay Condition Report for 2023

Bays included in this report:
Blackburn Bay, Dryman Bay

Summary:

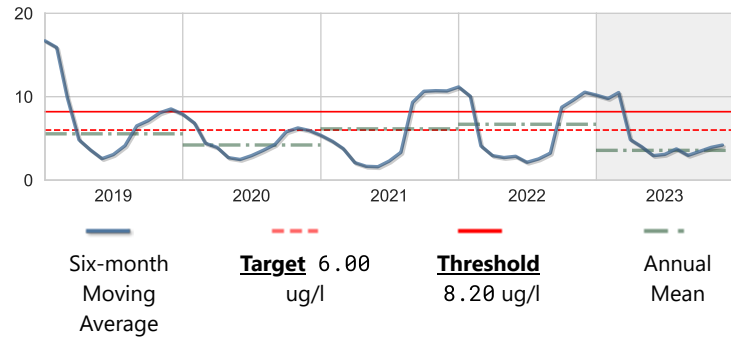
Chlorophyll a

Score: Excellent

Units: ug/l	Year 2023	Historical period of record
High	10.87	96.90
Mean	3.86	6.71
Low	0.78	0.20
No. of Samples	60	1147

Overall water quality in Blackburn Bay was already good, but improved to be excellent in 2023, with the mean values of all three measures of water quality pollution – Chlorophyll a, Total Nitrogen, and Total Phosphorus – decreasing so that they are below target levels.

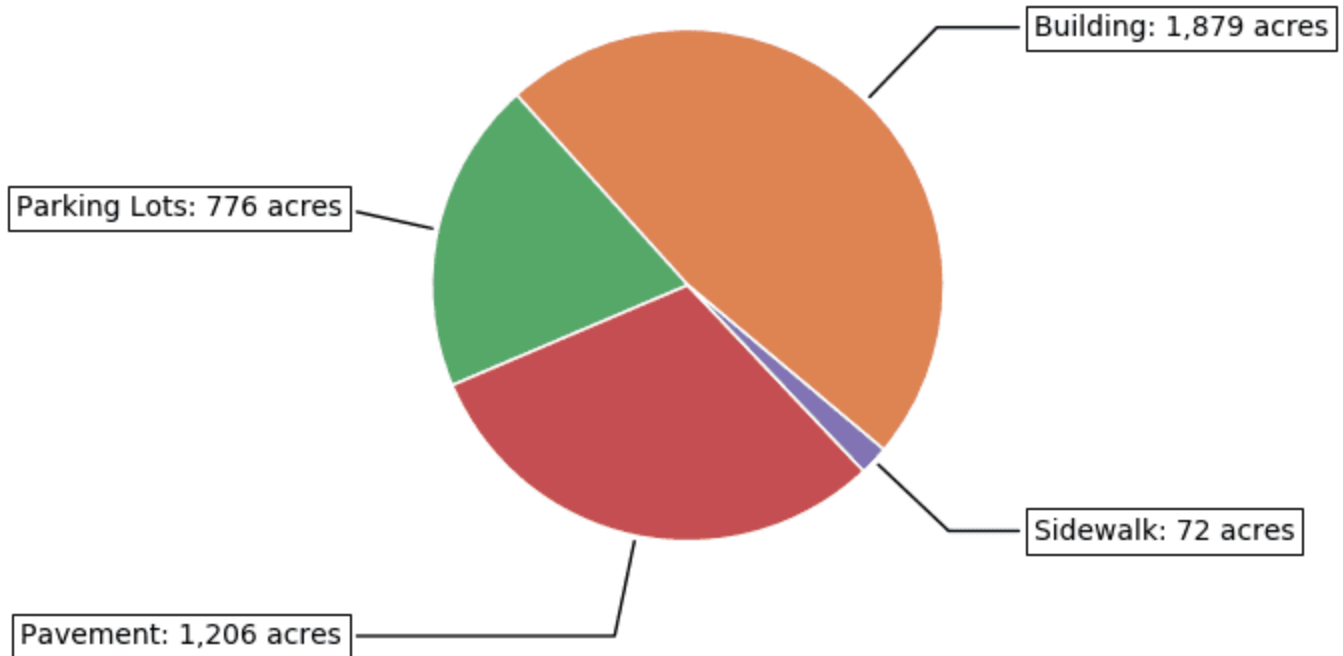
2014 Impervious Surface Coverage by Type

14% of the land area within the **Little Sarasota Bay Watershed** is covered by

in acres, within the Little Sarasota Bay Watershed

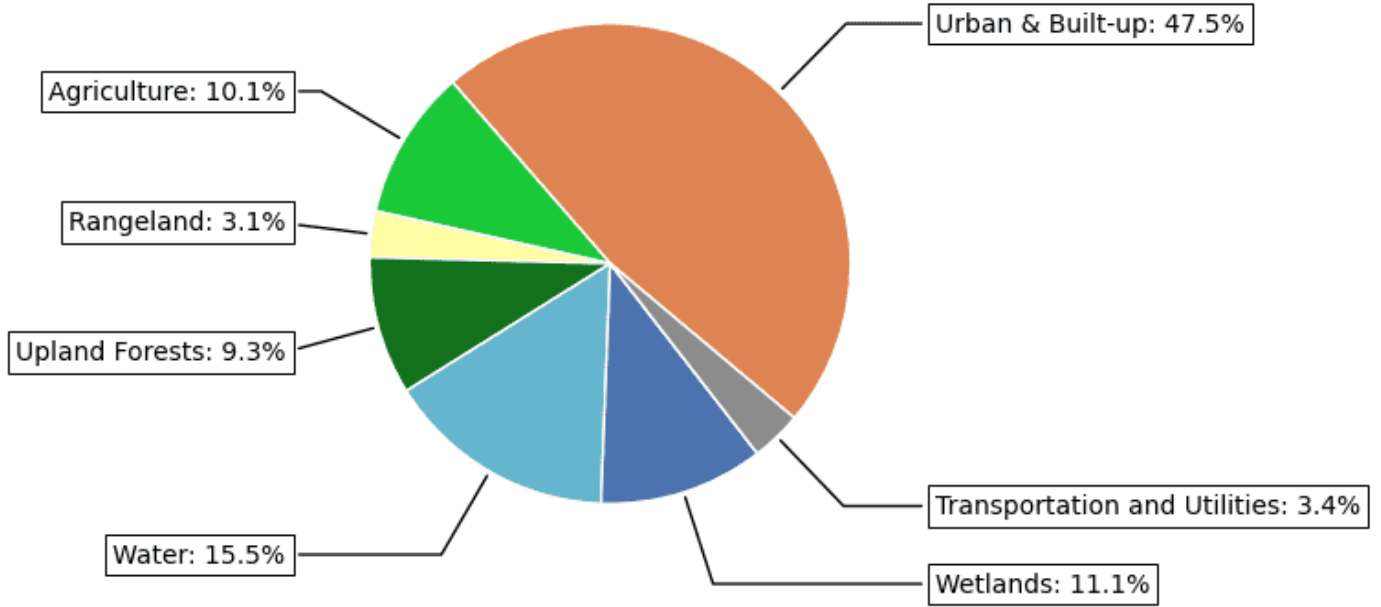
2020 Land Use / Land Cover for Little Sarasota Bay Watershed

as a percentage of land area for this watershed
