Little Sarasota Bay Condition Report for 2023

2023 Bay Conditions Report for Little Sarasota Bay

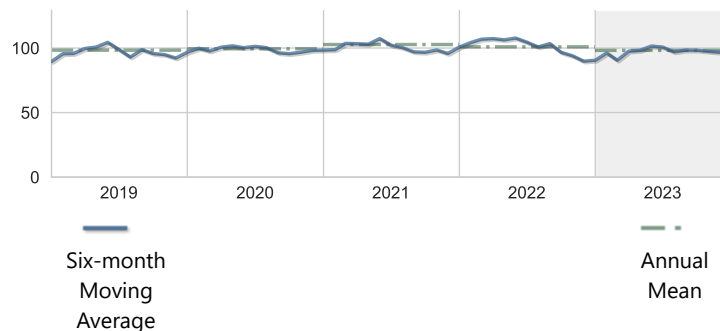
Dissolved oxygen saturation

Units: percent (%)	Year 2023	Historical period of record
High	140.00	153.00
Mean	99.17	97.18
Low	78.00	45.00
No. of Samples	54	1333

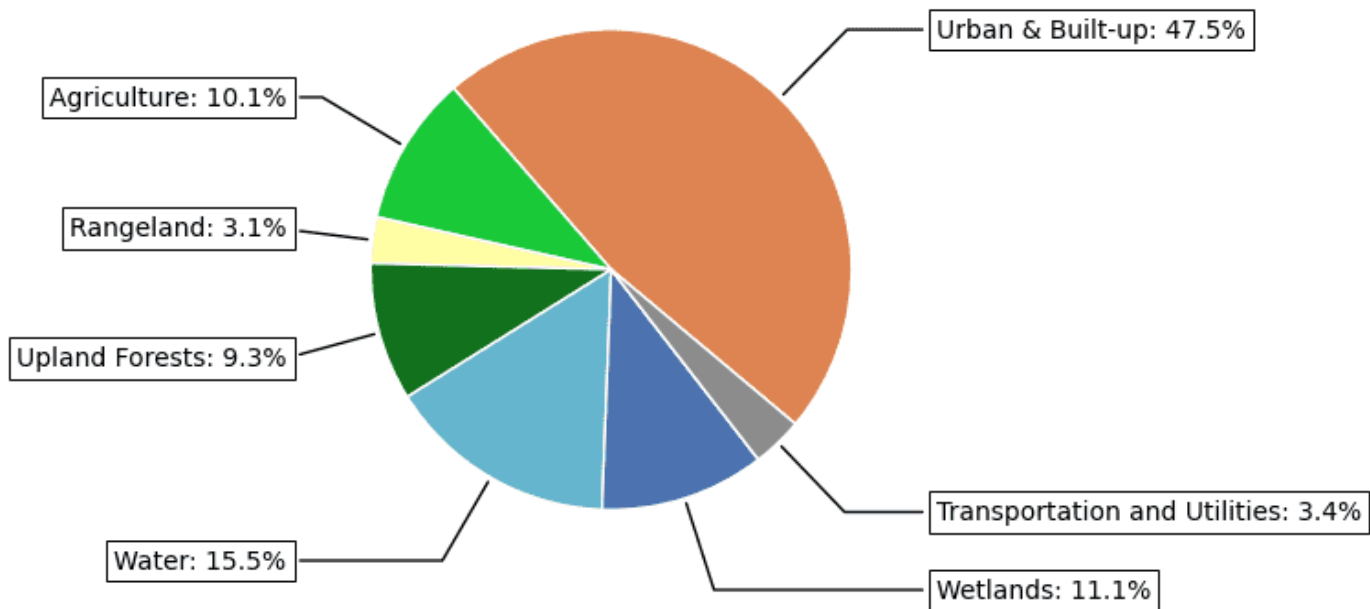
2020 Land Use / Land Cover for Little Sarasota Bay Watershed

as a percentage of land area for this watershed
