Upper Lemon Bay Condition Report for 2022

2022 Bay Conditions Report for Upper Lemon Bay

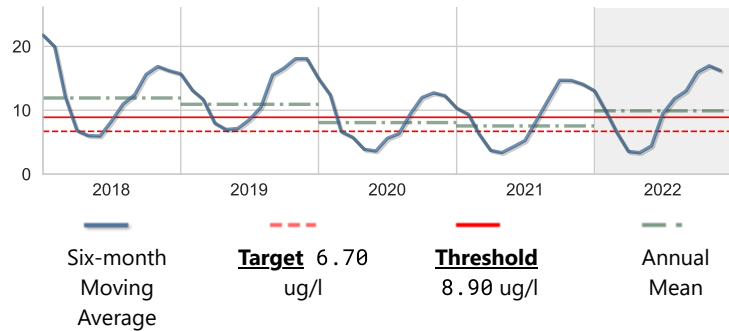
Chlorophyll a

Score: Caution

Units: ug/l	Year 2022	Historical period of record
High	71.32	85.01
Mean	9.91	9.70
Low	1.15	0.13
No. of Samples	90	2853

Water quality in Upper Lemon Bay deteriorated in 2022, with Total Nitrogen measured at a period-of-record high value of 1.585 mg/l. Both Total Nitrogen and Chlorophyll *a* mean values increased significantly from 2021, earning them "Caution" ratings. The high value for Chlorophyll *a* measured in 2022, 71.32 ug/l, was nearly double the value of the previous year. Torrential rain and storm debris in waterways related to Hurricane Ian in late September are the likely cause of this abrupt shift.

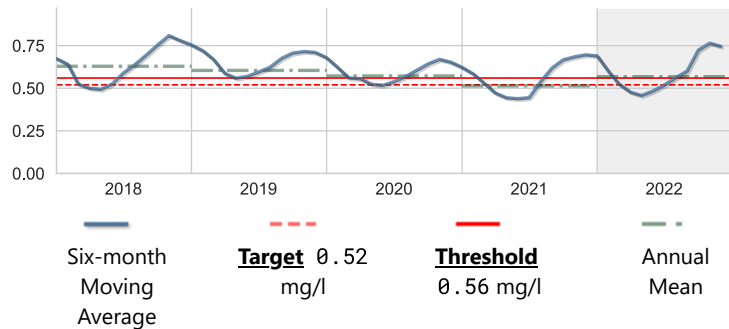
Nitrogen, Total

Score: Caution

Units: mg/l	Year 2022	Historical period of record
High	1.585	1.585
Mean	0.568	0.543
Low	0.275	0.055
No. of Samples	75	1737

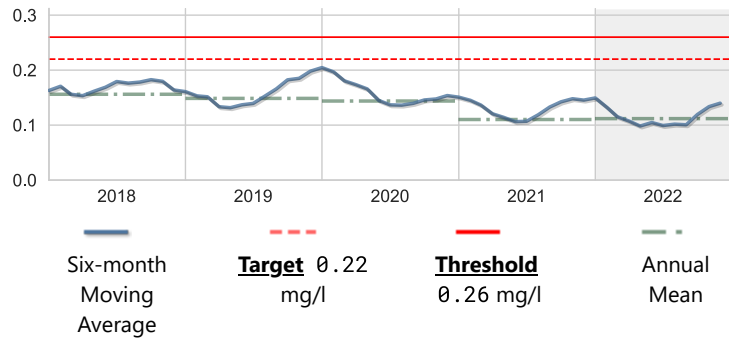
Phosphorus, Total

Score: Excellent

Units: mg/l	Year 2022	Historical period of record
High	0.280	0.880
Mean	0.112	0.159
Low	0.050	0.007
No. of Samples	75	1750

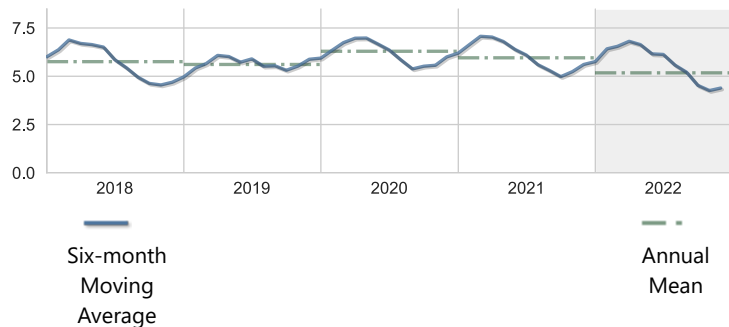
Dissolved Oxygen

Units: mg/l	Year 2022	Historical period of record
High	9.25	12.00
Mean	5.18	6.18
Low	1.47	0.20
No. of Samples	74	3295

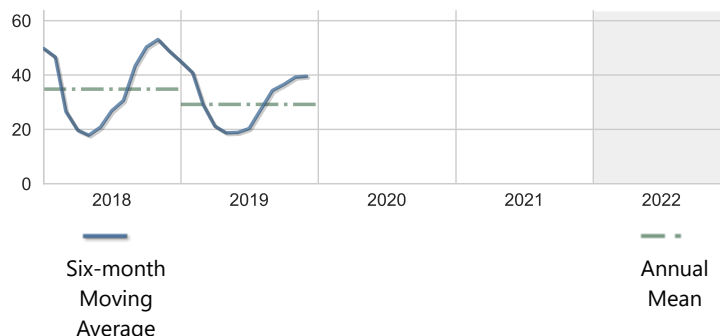
Apparent Color

Note: The latest available sample for this parameter is from December 2019

Units: PCU	Year 2022	Historical period of record
High		280.00
Mean		31.97
Low		4.00
No. of Samples	0	1498

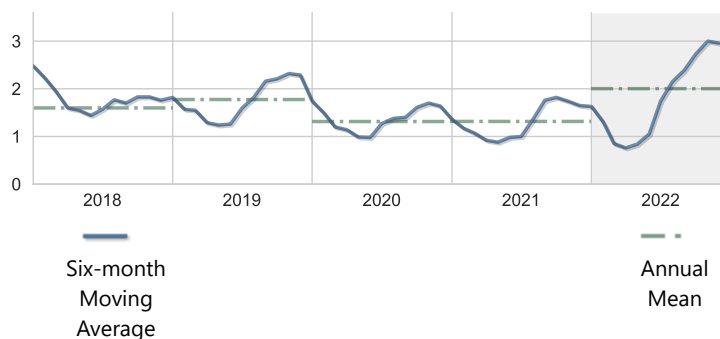
BOD, Biochemical oxygen demand

Units: mg/l	Year 2022	Historical period of record
High	7.20	7.60
Mean	2.00	1.75
Low	0.50	0.50
No. of Samples	60	1536

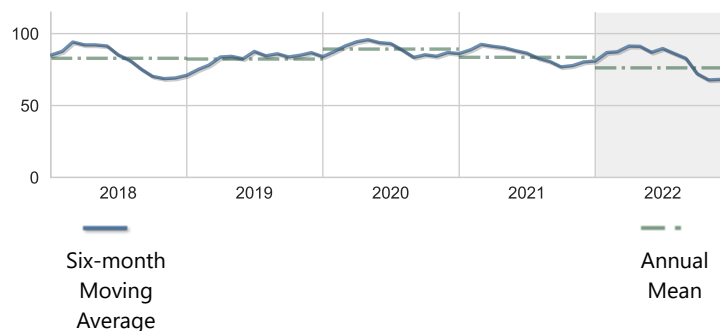
Dissolved oxygen saturation

Units: percent (%)	Year 2022	Historical period of record
High	121.00	180.07
Mean	76.19	88.72
Low	27.00	12.90
No. of Samples	74	3152

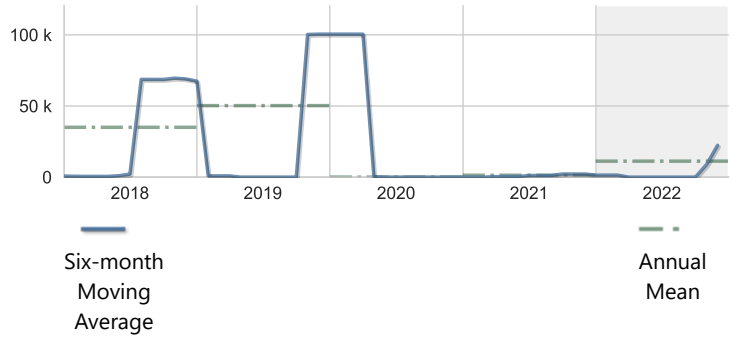
Karenia brevis ("red tide")

Units: #/l	Year 2022	Historical period of record
High	185000.00	4480000.00
Mean	11200.00	26224.80
Low	0.00	0.00
No. of Samples	60	1101

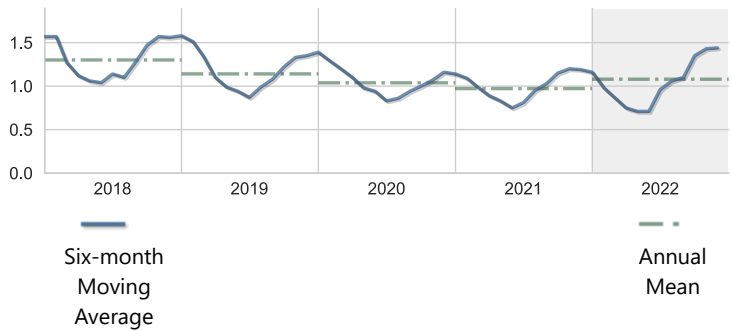
Light Attenuation

Units: K(1/m)	Year 2022	Historical period of record
High	2.99	3.85
Mean	1.08	1.13
Low	0.18	0.13
No. of Samples	60	1505

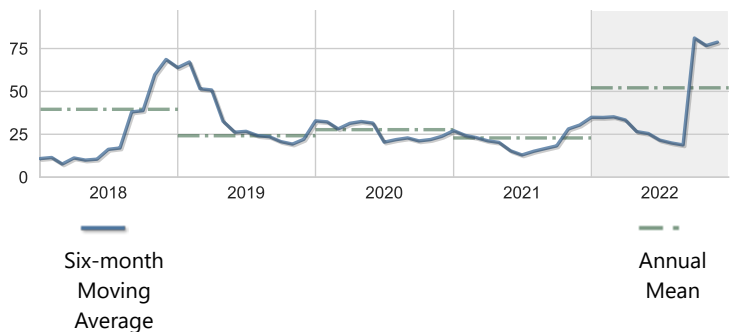
Nitrogen, Ammonia + Ammonium as N

Units: ug/l	Year 2022	Historical period of record
High	540.00	540.00
Mean	52.08	26.60
Low	5.00	5.00
No. of Samples	60	1680

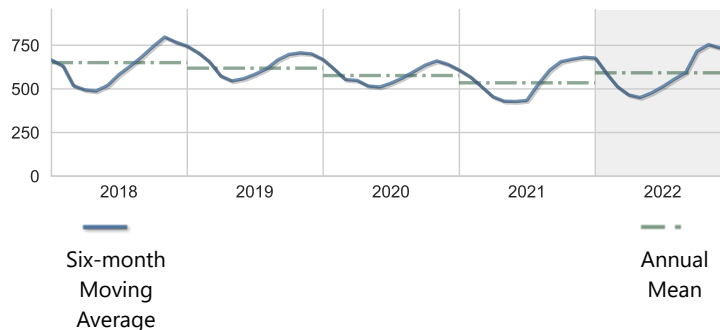
Nitrogen, Kjeldahl

Units: ug/l	Year 2022	Historical period of record
High	1580.00	1580.00
Mean	592.13	566.76
Low	270.00	50.00
No. of Samples	75	1750

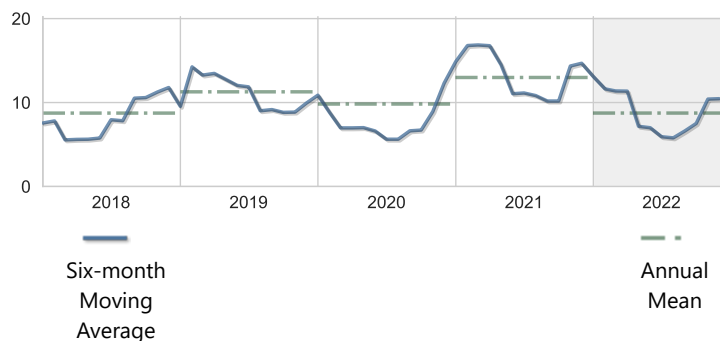
Nitrogen, Nitrite + Nitrate as N

Units: ug/l	Year 2022	Historical period of record
High	70.00	170.00
Mean	8.75	9.20
Low	4.00	4.00
No. of Samples	75	2181

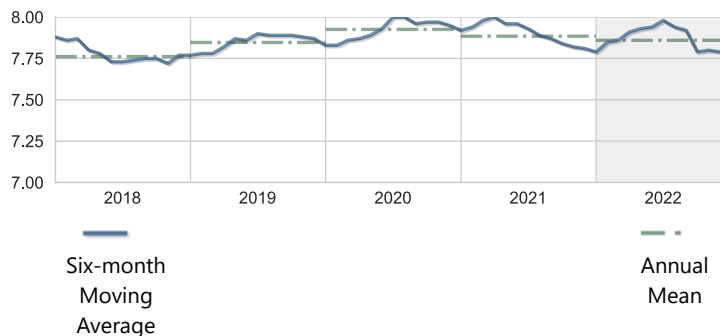
pH

Units: None	Year 2022	Historical period of record
High	8.29	8.90
Mean	7.86	7.96
Low	7.19	4.80
No. of Samples	74	2855

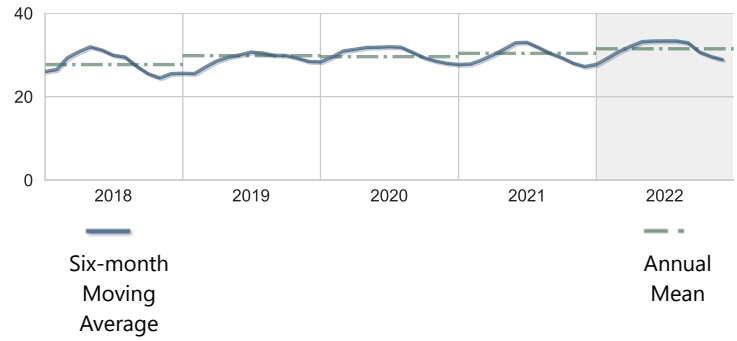
Salinity

Units: PSS	Year 2022	Historical period of record
High	37.60	40.60
Mean	31.48	29.78
Low	19.00	2.80
No. of Samples	88	3640

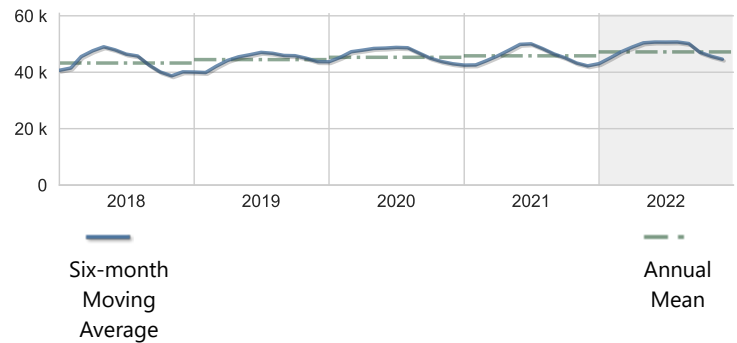
Specific conductance

Units: umho	Year 2022	Historical period of record
High	54200.00	60590.00
Mean	47198.33	45636.82
Low	30600.00	5800.00
No. of Samples	60	1683

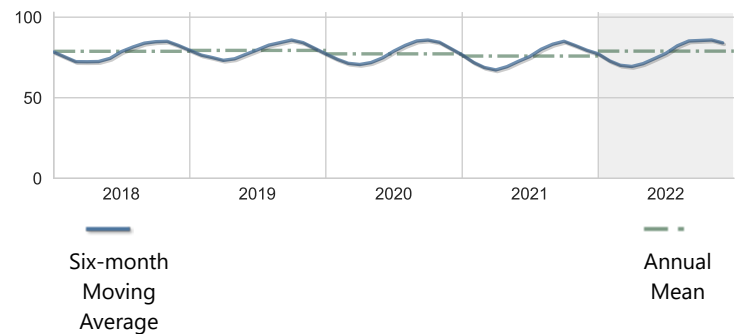
Temperature, water

Units: deg F	Year 2022	Historical period of record
High	90.86	107.60
Mean	78.93	77.93
Low	58.46	46.76
No. of Samples	73	3628

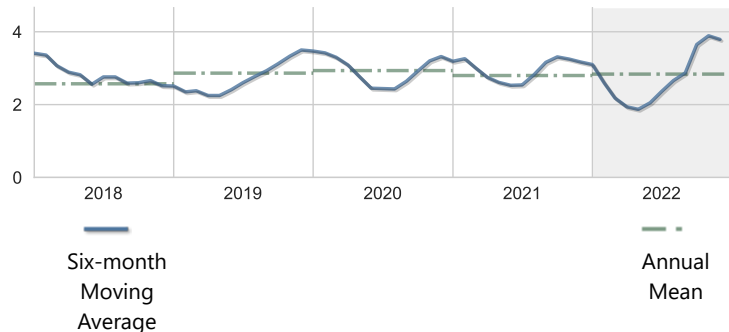
Turbidity

Units: NTU	Year 2022	Historical period of record
High	17.00	22.00
Mean	2.84	2.95
Low	1.10	0.10
No. of Samples	75	2972

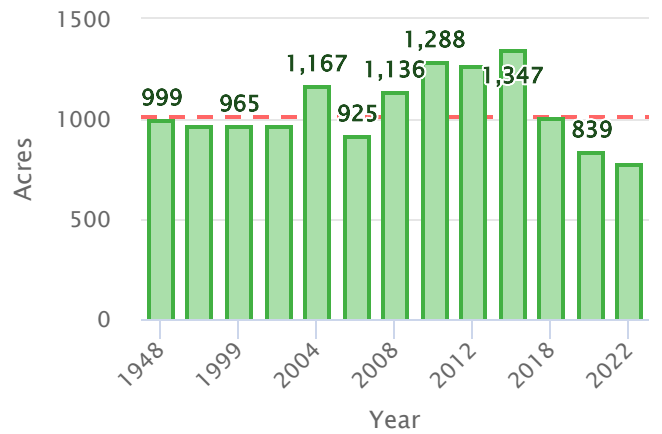
Seagrass Acreage Variation within Upper Lemon Bay

--- Target 1,010 acres

Note: Seagrass acreage values shown above are for Upper Lemon Bay only. The target for seagrass acreage for Upper Lemon Bay is 1,010 acres; for Lower Lemon Bay it is 2,880 acres.

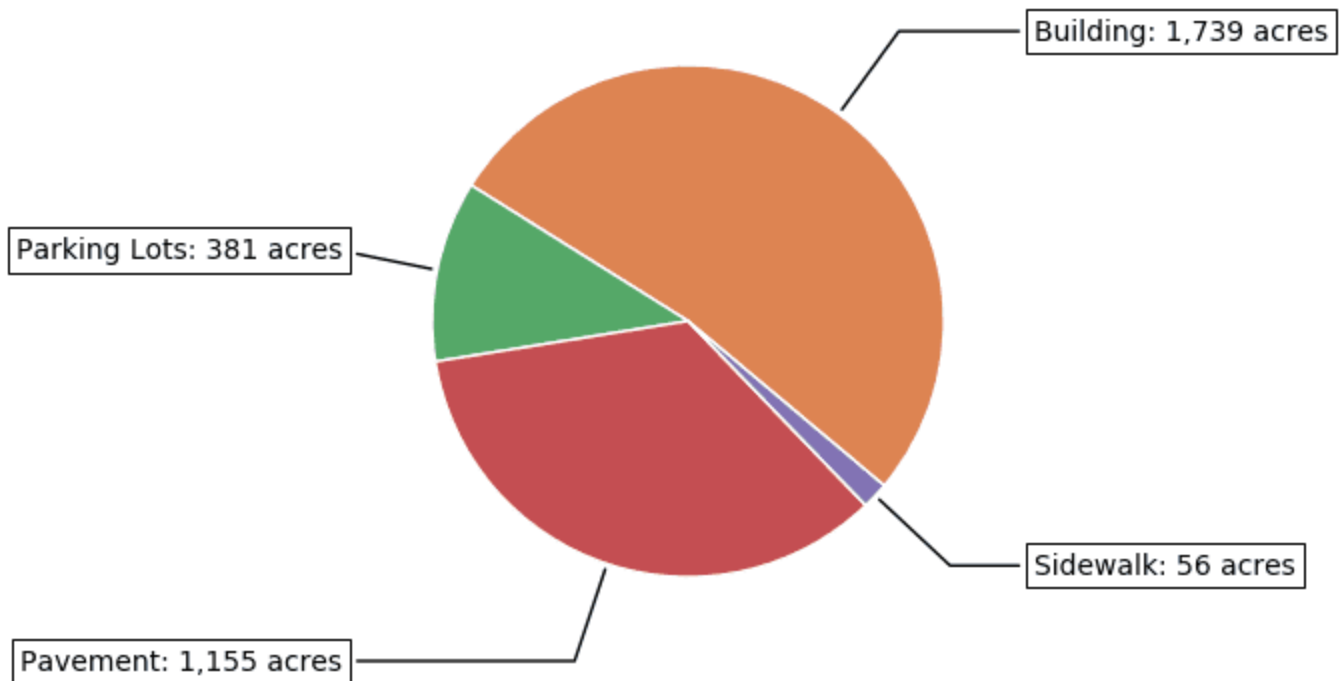
2014 Impervious Surface Coverage by Type

10% of the land area within the **Lemon Bay Watershed** is covered by impervious

in acres, within the Lemon Bay Watershed

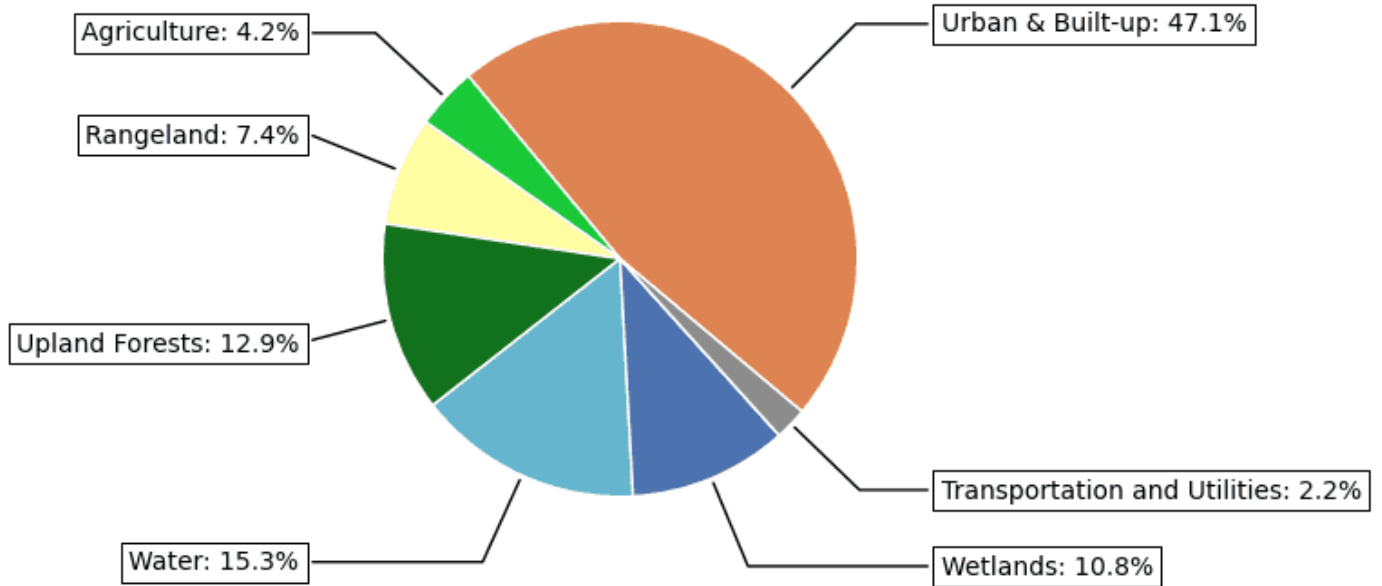
2020 Land Use / Land Cover for Lemon Bay Watershed

Upper Lemon Bay is located within the Lemon Bay Watershed. The chart below shows the land use / land cover characteristics for Lemon Bay Watershed within the boundary of this Water Atlas. [**View details about the Lemon Bay Watershed »**](#)

as a percentage of land area for this watershed
