Matheny Creek Condition Report for 2021

Matheny Creek

Water Chemistry Ratings | Freshwater Portion of the Creek

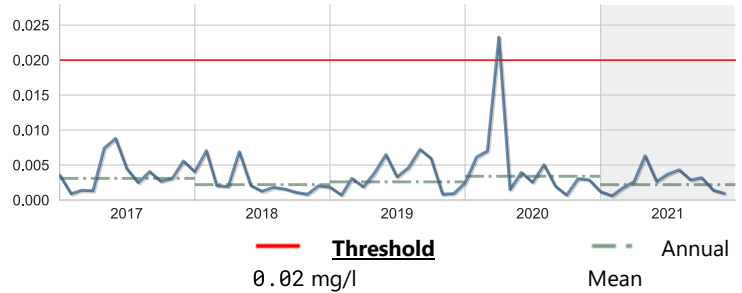
Chlorophyll a

Score: Pass

Units: mg/l	Year 2021	Historical period of record
High	0.0117	0.10
Mean	0.0022	0.0028
Low	0.0006	0.0005
No. of Samples	24	570

Five-year Rolling Average

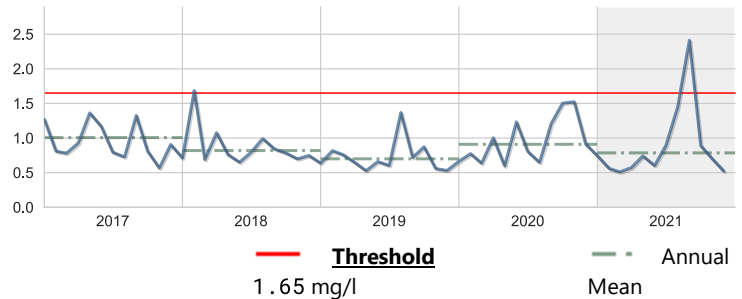
Nitrogen, Total

Score: Pass

Units: mg/l	Year 2021	Historical period of record
High	2.493	3.154
Mean	0.7852	0.7427
Low	0.448	0.0017
No. of Samples	24	413

Five-year Rolling Average

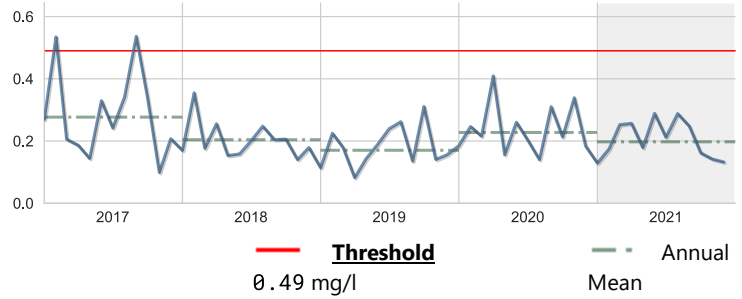
Phosphorus, Total

Score: Pass

Units: mg/l	Year 2021	Historical period of record
High	0.389	1.78
Mean	0.1974	0.2105
Low	0.083	0.041
No. of Samples	24	476

Five-year Rolling Average

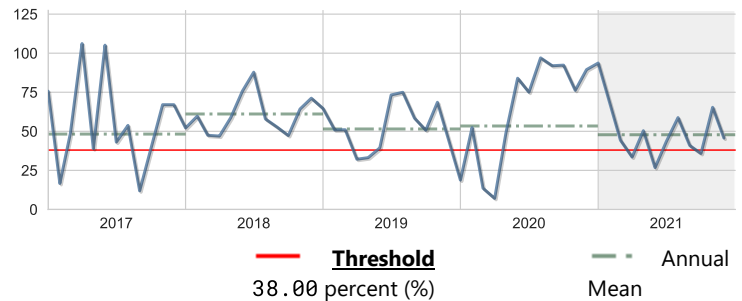
Dissolved Oxygen Saturation

Note: Low DO saturation also may be naturally influenced by inflows from nearby wetlands or groundwater sources.

Score: Pass

Units: percent (%)	Year 2021	Historical period of record
High	98.8439	213.70
Mean	47.81	59.25
Low	13.30	2.5837
No. of Samples	24	458

Five-year Rolling Average

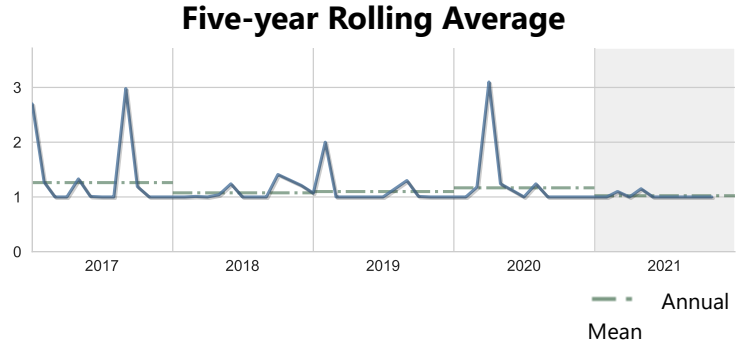
BOD, Biochemical oxygen demand

Units: mg/l	Year 2021	Historical period of record
High	1.33	10.30
Mean	1.02	0.99
Low	1.00	0.50
No. of Samples	22	444

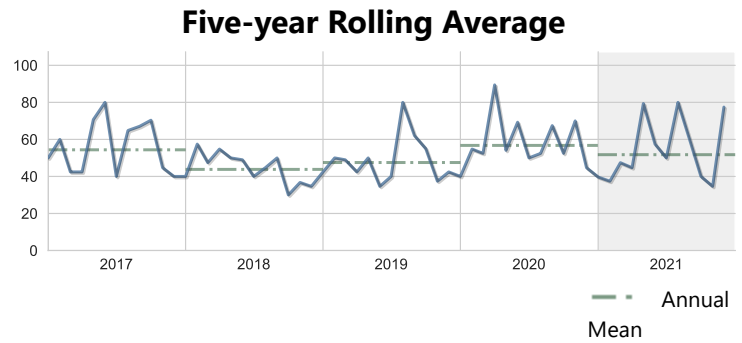
Color

Units: PCU	Year 2021	Historical period of record
High	100.00	120.00
Mean	51.75	50.45
Low	30.00	20.00
No. of Samples	24	548

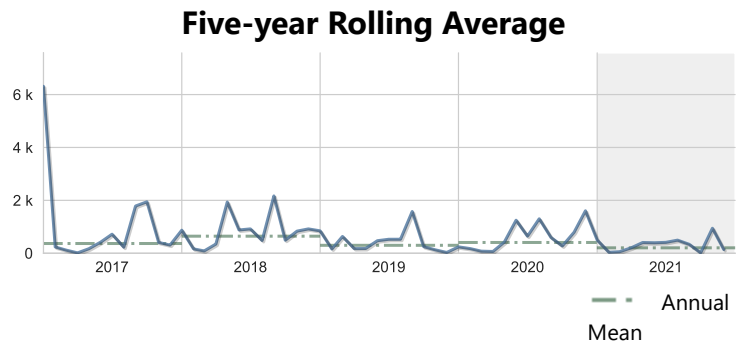
Escherichia coli

Units: cfu/100ml	Year 2021	Historical period of record
High	1086.00	8164.00
Mean	204.56	384.65
Low	10.00	10.00
No. of Samples	24	236

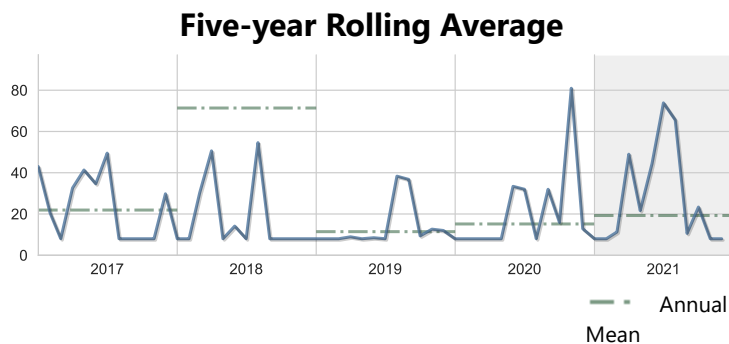
Nitrogen, Ammonia + Ammonium as N

Units: ug/l	Year 2021	Historical period of record
High	107.00	988.00
Mean	19.26	16.93
Low	8.00	0.008
No. of Samples	24	507

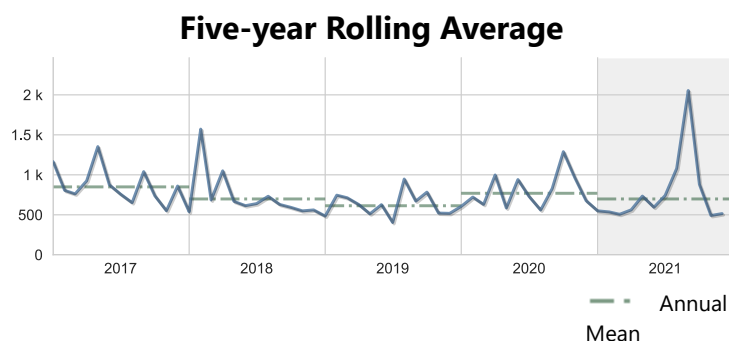
Nitrogen, Kjeldahl

Units: ug/l	Year 2021	Historical period of record
High	2110.00	2970.00
Mean	698.12	705.65
Low	444.00	207.00
No. of Samples	24	476

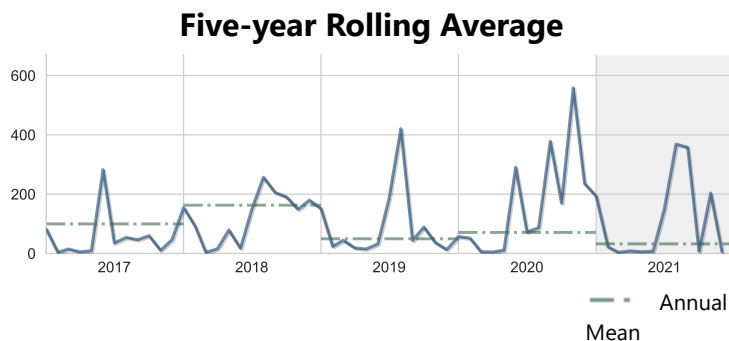
Nitrogen, Nitrite + Nitrate as N

Units: ug/l	Year 2021	Historical period of record
High	383.00	947.00
Mean	32.46	41.26
Low	4.00	4.00
No. of Samples	24	480

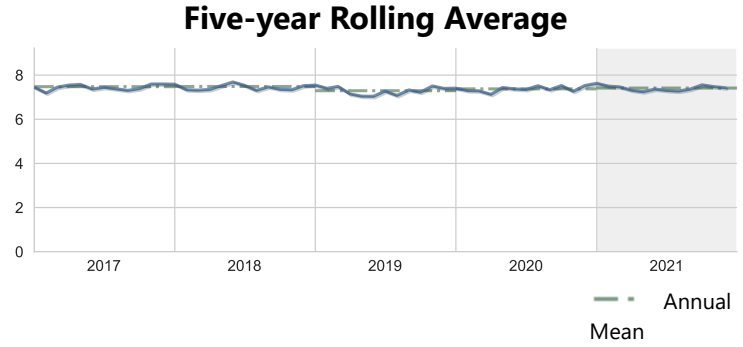
pH

Units: None	Year 2021	Historical period of record
High	7.7575	8.82
Mean	7.41	7.47
Low	7.14	6.46
No. of Samples	24	525

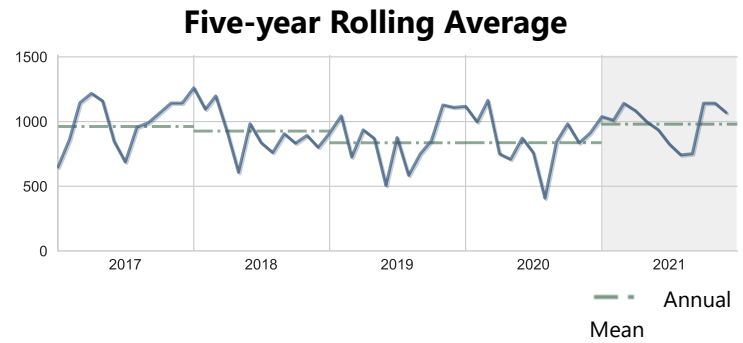
Specific conductance

Units: umho	Year 2021	Historical period of record
High	1264.00	19300.00
Mean	980.09	854.38
Low	695.074	0.667
No. of Samples	24	452

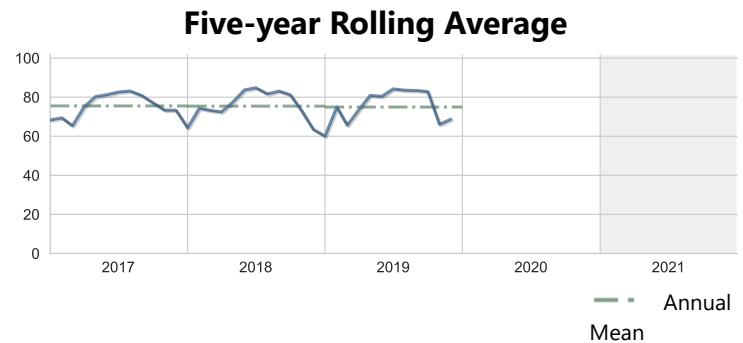
Temperature, water

Units: deg F	Year 2021	Historical period of record
High	185.2772	188.1984
Mean	168.15	80.81
Low	145.848	36.05
No. of Samples	24	452

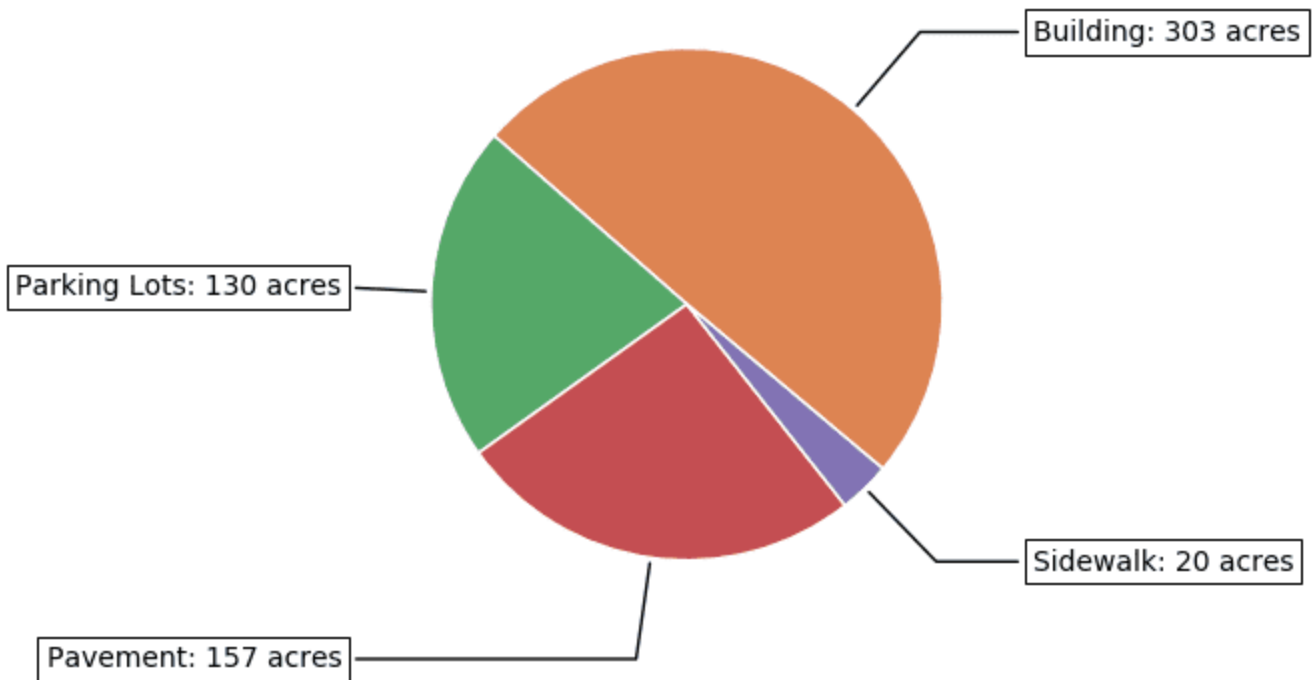
2014 Impervious Surface Coverage by Type

35% of the land area within the **Matheny Creek Basin** is covered by impervious

surfaces

in acres, within the Matheny Creek Basin

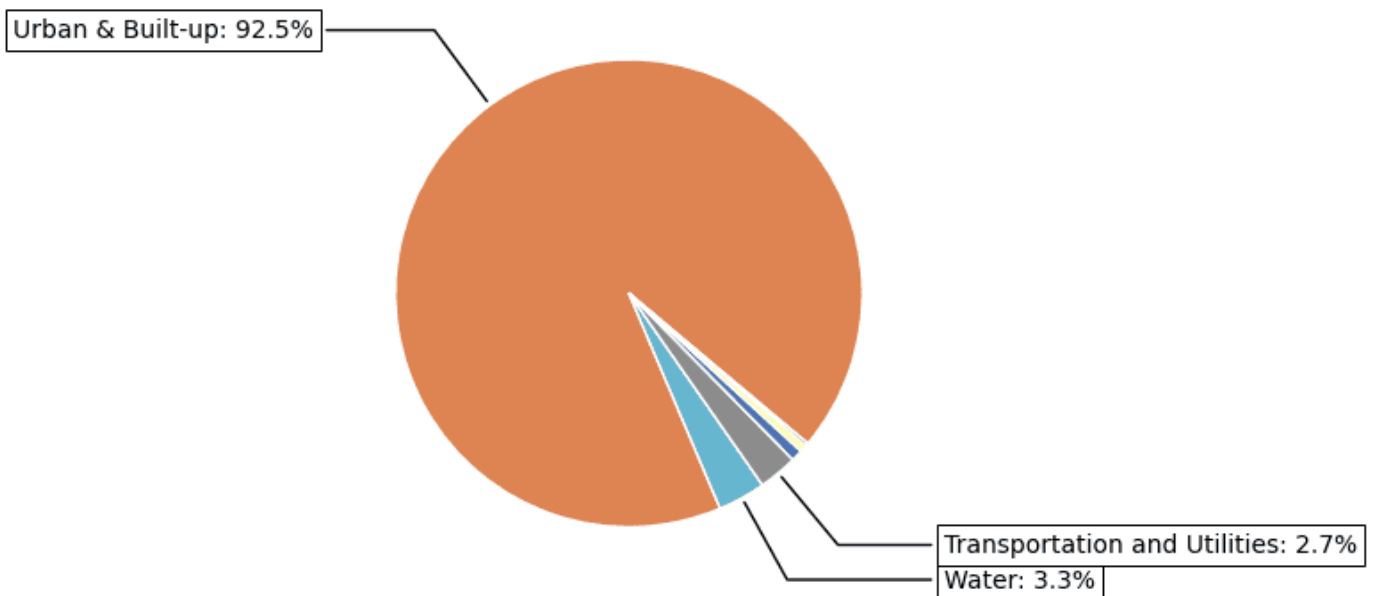
2020 Land Use / Land Cover for Matheny Creek Basin
as a percentage of land area for this basin
