## Upper Lemon Bay Condition Report for 2023

### Summary:

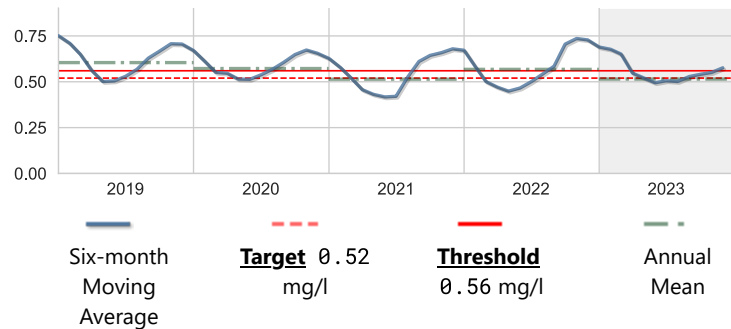
## Nitrogen, Total

**Score:** Excellent

Units: mg/l	Year 2023	Historical period of record
<b>High</b>	1.065	1.585
<b>Mean</b>	0.515	0.538
<b>Low</b>	0.084	0.055
<b>No. of Samples</b>	80	1724

Water quality in Upper Lemon Bay deteriorated in 2022, with Total Nitrogen measured at a period-of-record high value of 1.585 mg/l. Both Total Nitrogen and Chlorophyll *a* mean values increased significantly from 2021, earning them "Caution" ratings. The high value for Chlorophyll *a* measured in 2022, 71.32 ug/l, was nearly double the value of the previous year. Torrential rain and storm debris in waterways related to Hurricane Ian in late September are the likely cause of this abrupt shift.

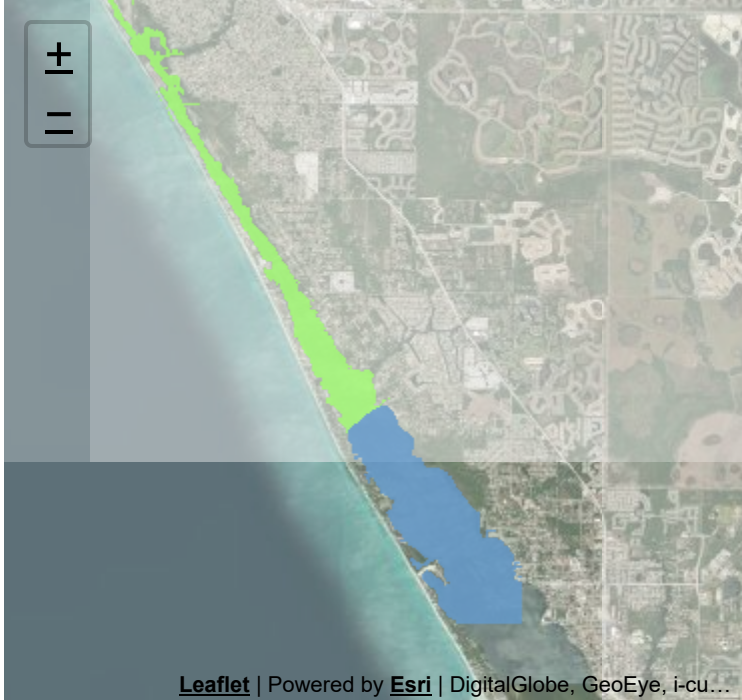
January

Contour mapping is one of the best ways to visualize spatial differences in coastal water quality. The interactive map shown below presents monthly data for one selected water quality indicator atop an aerial view of the bay. Choose a different water quality parameter from the list at the top to change the map.

Showing 2023 Monthly Contour Maps for: Chlorophyll a ▼

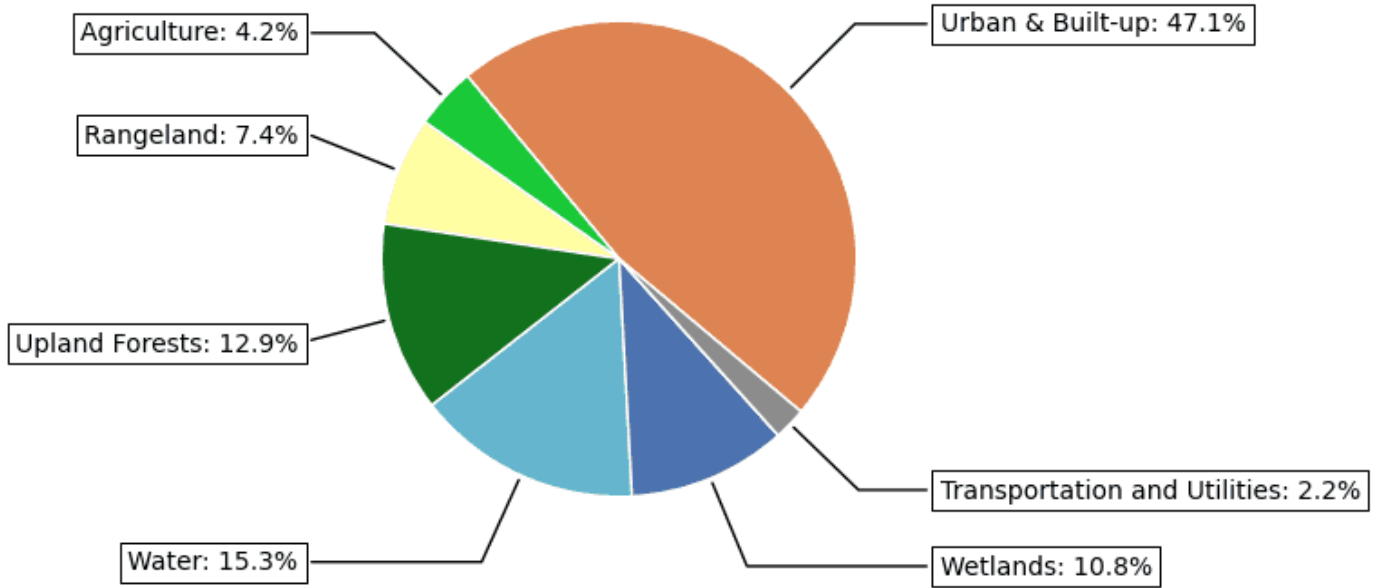
## 2020 Land Use / Land Cover for Lemon Bay Watershed

as a percentage of land area for this watershed
